**Flood Control Project Maintenance
Levee Inspections**

Fall 2011 Levee Maintenance Deficiency Summary Report

Sutter Maintenance Yard Nelson Bend

Waterway			Bank	Unit Miles
Unit No. 01 Feather River West Levee-Nelson Bend				0.50

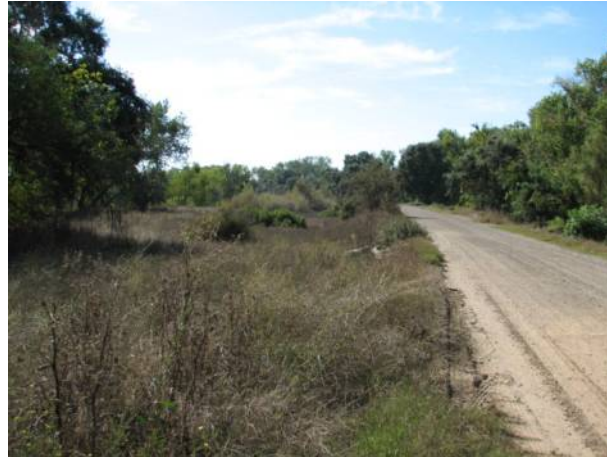
Levee Mile Report Line	1
Start Levee Mile	0.01
End Levee Mile	0.45
Location	Water Side
Category	Earthen Levee
Item	Vegetation

This photo shows the waterside vegetation at levee mile 0.01.

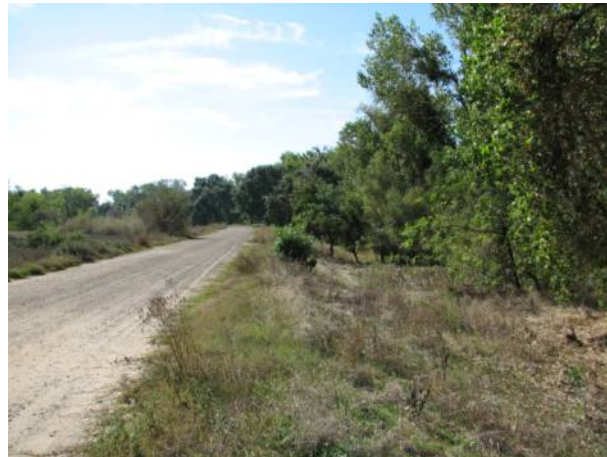
Levee Mile Report Line	2
Start Levee Mile	0.01
End Levee Mile	0.45
Location	Land Side
Category	Earthen Levee
Item	Vegetation

This photo shows the landside vegetation at levee mile 0.01.
